**Flood Control Project Maintenance
Levee Inspections****LMA District Cover Sheet****Spring 2011 Levee Inspection Results****San Joaquin County Flood Control and Water Conservation District**

Spring 2011 Levee Inspection Results

San Joaquin County Flood Control and Water Conservation District

Waterway			Bank	Unit Miles
Unit No. 01 Littlejohn Creek			Left	2.87

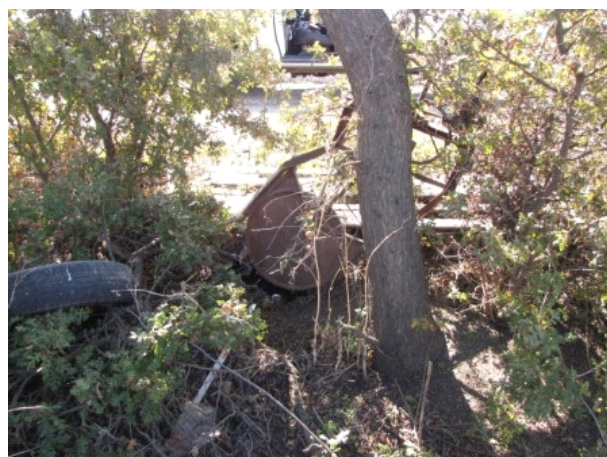
Levee Mile Report Line	9
Start Levee Mile	1.00
End Levee Mile	1.00
Location	Water Side
Category	Interior Drainage & Piping Systems
Item	Sluice / Slide Gates
View of a slide gate that has been badly damaged and is unable to be closed on the waterward side of the levee.	
pkazi_s_20110328_005.jpg

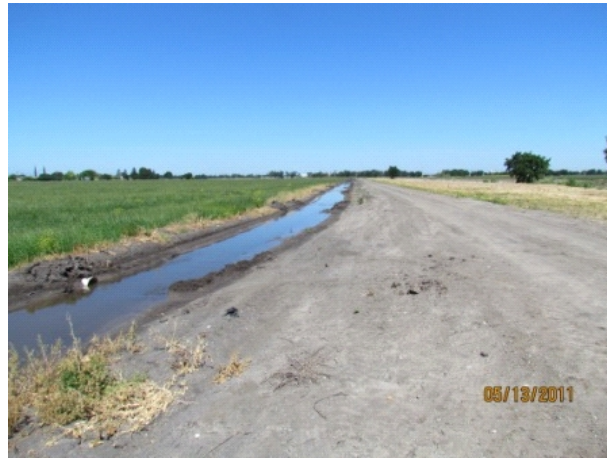
pkazi_s_20110517_551.jpg

An agricultural ditch with running water was found on the landside of the levee. The picture was taken from the crown looking downstream.

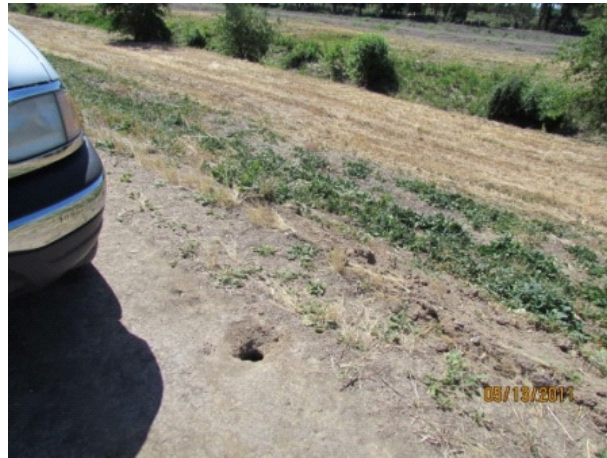
pkazi_s_20110517_550.jpg

A rodent hole was found on the crown of the levee. The picture was taken from the crown looking toward the waterside of the levee.

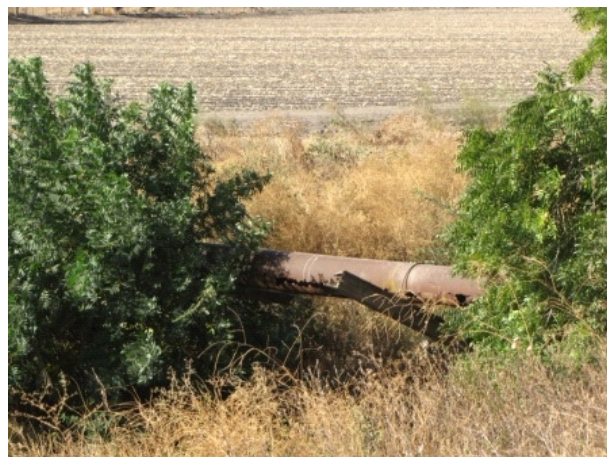
pkazi_s_20110328_021.jpg

12	2.66	2.66	Earthen Levee	Encroachments	WS	W	Pipe Inspector Comments: Pipe crossing the channel has corroded and can carry water to/from the channel. This pipe needs immediate attention but is likely an older encroachment and may predate the project.	37.888853 ° -121.258640 °	37.888853 ° -121.258640 °	8 Y

View of a pipe crossing the channel with severe corrosion.

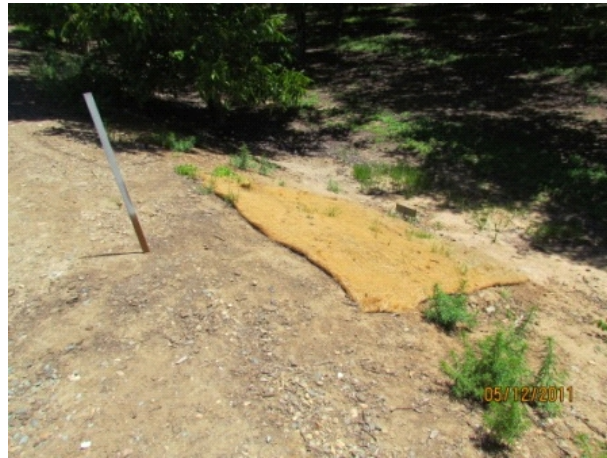
pkazi_s_20110517_547.jpg

The erosion site has been repaired by regrading the surface and applying erosion control mat with sod at the damaged location. The picture was taken from the crown looking upstream.

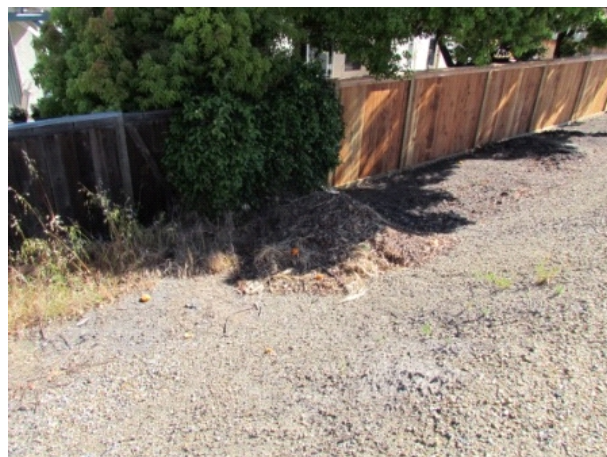
pkazi_s_20110502_521.jpg

Debris found on the landside of the levee. The picture was taken from the crown looking upstream.

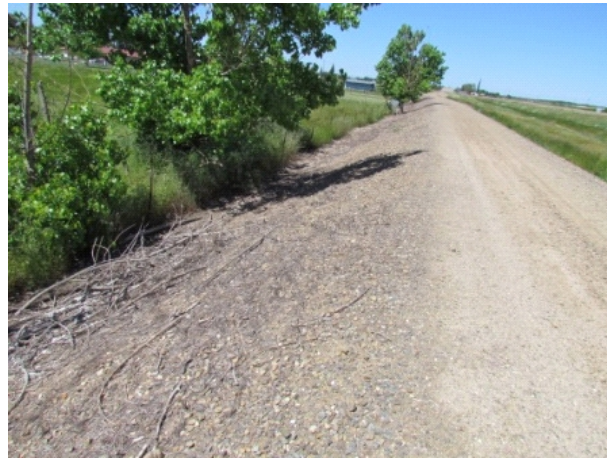
pkazi_s_20110508_527.jpg

Erosion site was repaired on the landside of the levee. The picture was taken from the crown of the levee looking upstream.

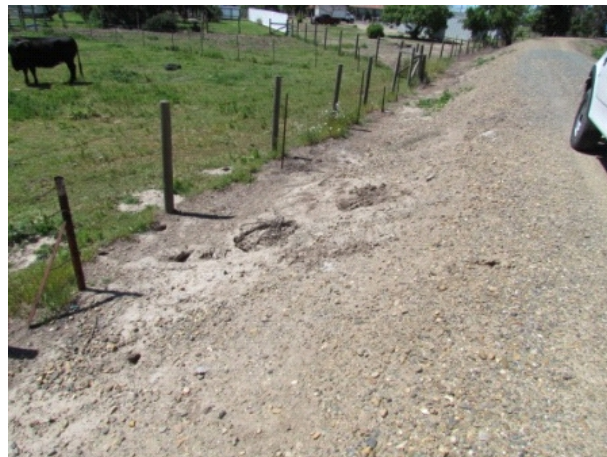
pkazi_s_20110508_528.jpg

Rodent hole was found on the toe of the landside of the levee during Spring 2011 inspection. The picture was taken from the crown of the levee looking upstream.

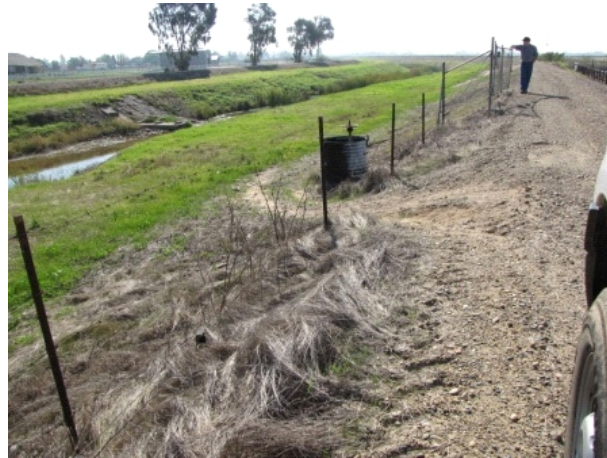
pkazi_s_20110328_159.jpg

View of damage to the waterward slope caused by pedestrian traffic looking downstream.

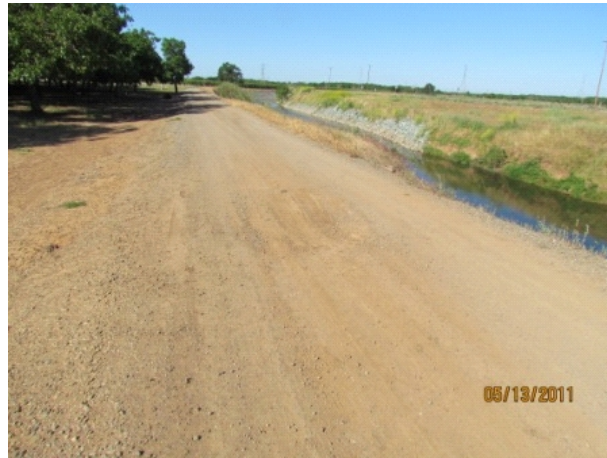
Levee Mile Report Line	9
Start Levee Mile	0.98
End Levee Mile	0.98
Location	Crown
Category	Earthen Levee
Item	Crown Surface / Depressions / Rutting
Depression on the crown was found on the levee looking downstream.	
pkazi_s_20110526_604.jpg

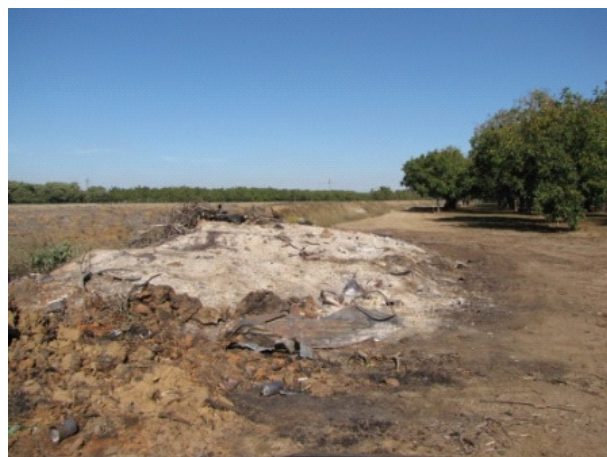
Levee Mile Report Line	22
Start Levee Mile	3.78
End Levee Mile	3.78
Location	Water Side
Category	Earthen Levee
Item	Encroachments
View of burn pile that has been burned and a location where a landowner recently removed prunings as requested looking upstream.	
pkazi_s_20110328_286.jpg

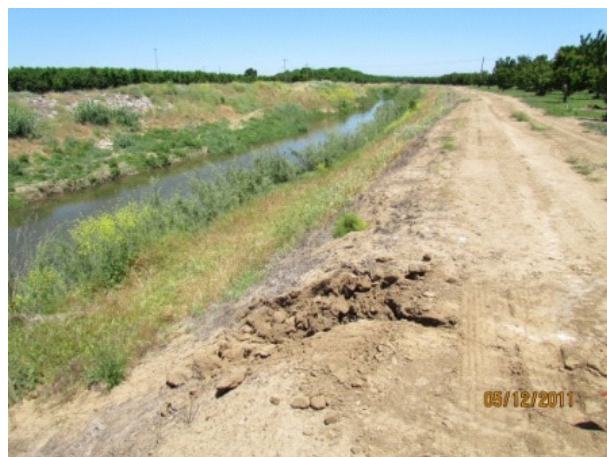
Levee Mile Report Line	50
Start Levee Mile	8.08
End Levee Mile	8.08
Location	Water Side
Category	Earthen Levee
Item	Slope Stability
Slope stability was found on the shoulder of the waterside of the levee. The picture was taken from the crown looking upstream.	
pkazi_s_20110526_600.jpg
